Vladimir DEKYS¹, Ondrej DVOULETY²

AN CONTRIBUTION TO THE CONDITION MONITORING OF FANS

Summary. One reason for failure of fan is suppression to float a shaft's bearing in the bearing housings. As a result of this disorder leads to blocking axial displacement of bearing, thrust to the growth of the forces acting on the bearing, and then to his accident. The article deals with the identification of the symptoms of this condition in the data from diagnostic measurements and presents the results of practice.

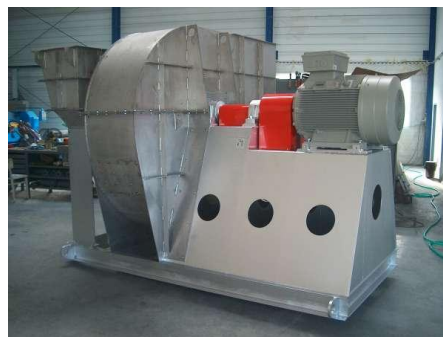
Fig. 1. Overhung centrifugal fans
Rys. 1. Wentylator odśrodkowy

At the Fig. 1 is object of our measurement – overhung centrifugal fan exhausts of gas from the filter.

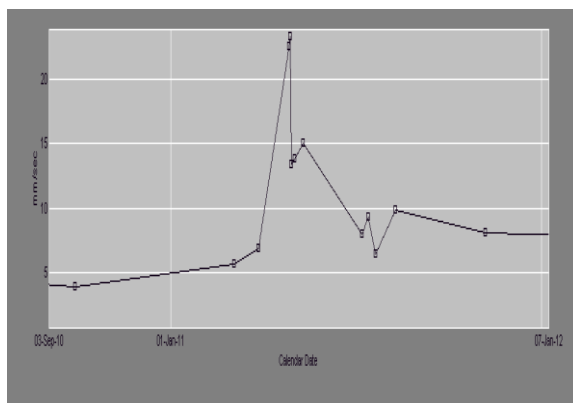
1. Multiple vibration increase of bearings in the axial direction at failure stage. In our case, the increase was approximately four times, in Fig. 2.

- a. In Fig. 2 is trend of electromotor axial vibration by coupling with increasing vibration in this direction from $5,7 \text{ mms}^{-1}$ up to $23,3 \text{ mms}^{-1}$.
- b. In Fig. 8 is trend of fan bearing vibration by coupling in axial vibration with increasing from $5,2 \text{ mms}^{-1}$ up to $20,4 \text{ mms}^{-1}$.
- c. In Fig. 6 is trend of fan bearing vibration by impeller in axial vibration with increasing from $5,1 \text{ mms}^{-1}$ up to $21,1 \text{ mms}^{-1}$.

Fig. 2. Trend of electromotor axial vibration by coupling with increasing vibration from $5,7 \text{ mms}^{-1}$ up to $23,3 \text{ mms}^{-1}$

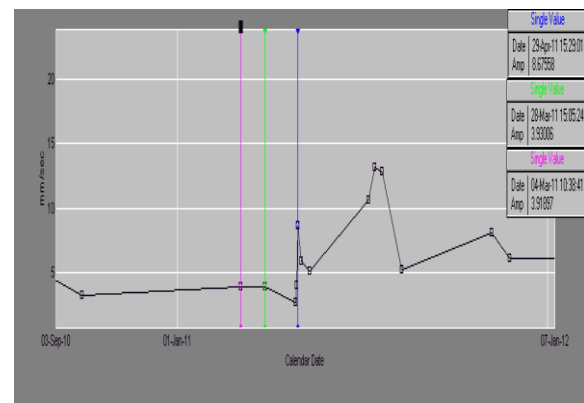
2. The growth of vibration in the rotor bearing houses by coupling other than axial direction is depicted in Fig. 3 and Fig. 4.

- a. In Fig. 3 is trend of fan bearing vibration by coupling in horizontal direction with increasing from $3,9 \text{ mms}^{-1}$ up to $8,7 \text{ mms}^{-1}$. The increase however is significantly lower in horizontal direction than in an axial direction.
- b. In Fig. 4 is trend of fan bearing vibration by coupling in vertical direction with increasing from $3,5 \text{ mms}^{-1}$ up to $6,2 \text{ mms}^{-1}$. The increase however is significantly lower in horizontal and vertical directions than in an axial direction.

Fig. 3. Trend of fan bearing vibration by coupling in horizontal direction with increasing from $3,9 \text{ mms}^{-1}$ up to $8,7 \text{ mms}^{-1}$

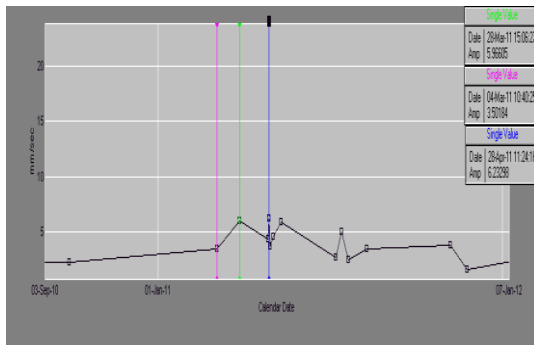
Fig. 4. Trend of fan bearing vibration by coupling in vertical direction with increasing from $3,5 \text{ mms}^{-1}$ up to $6,2 \text{ mms}^{-1}$

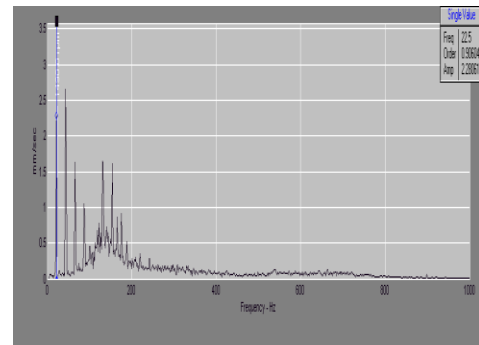
4. A velocity spectrum of fan bearing by coupling in vertical direction at 04/28/2011 is in Fig. 5. The spectrum is interesting occurrence harmonic frequency fan speed. This fact can be interpreted as the growth of vibration in the radial direction (the response of the system) involved non-linear properties and not fan speed frequency as in Fig. 8. This can be regarded as the accompanying symptom of failure.

Fig. 5. A velocity spectrum of fan bearing by coupling in vertical direction at 04/28/2011, failure

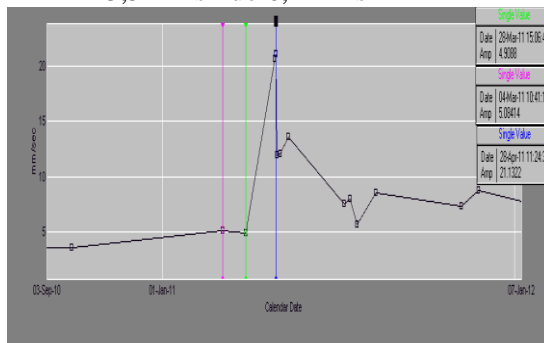
Fig. 6. Trend of fan bearing vibration by impeller in axial vibration with increasing from $5,1 \text{ mms}^{-1}$ up to $21,1 \text{ mms}^{-1}$

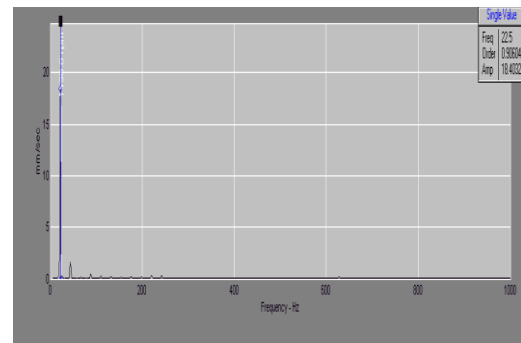
3. A velocity spectrum of fan bearing by coupling in axial direction at 04/28/2011 is in Fig. 7. The dominant peak is at fan speed frequency. This peak has caused an increase in the trend in axial direction.

Fig. 7. A velocity spectrum of fan bearing by coupling in axial direction at 04/28/2011. The dominant peak is at fan speed frequency

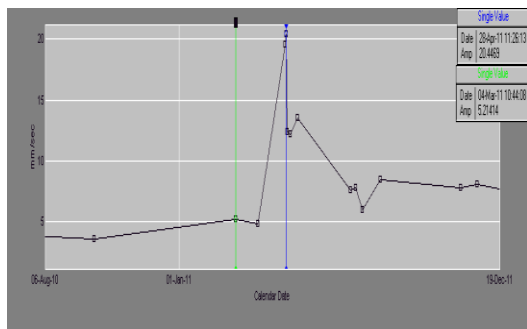
Fig. 8. Trend of fan bearing vibration by coupling in axial vibration with increasing from $5,2 \text{ mms}^{-1}$ up to $20,4 \text{ mms}^{-1}$

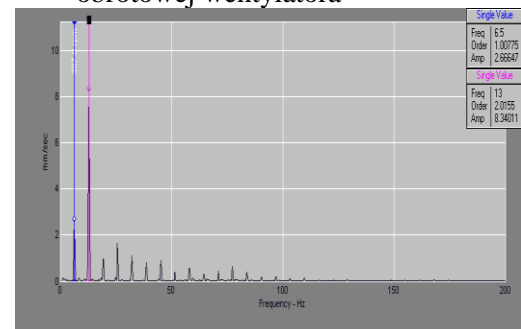
2. For drive end (DE) of crusher are peak at crusher speed frequency approximately the same, different are second harmonics in Fig. 9 and Fig. 10 in axial direction.

Fig. 9. The crusher, spectrum in axial direction of rotor bearing, DE with harmonics, failure

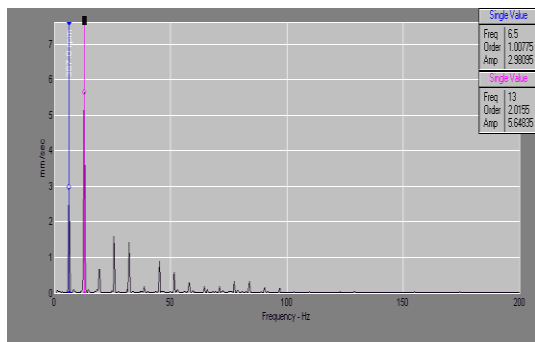
Fig. 10. The crusher, spectrum in axial direction of rotor bearing, DE with harmonics, after failure. Decrease in the second harmonic

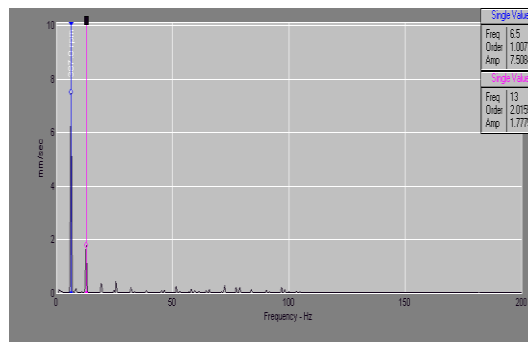
1. The peak at crusher speed frequency (at 6.5 Hz) in axial direction is symptom of described failure, Fig. 11 (failure) and Fig. 12 (after repair) for non drive end (NDE).

Fig. 11. The peak at crusher speed frequency (at 6.5 Hz) in axial direction of rotor bearing, NDE, failure

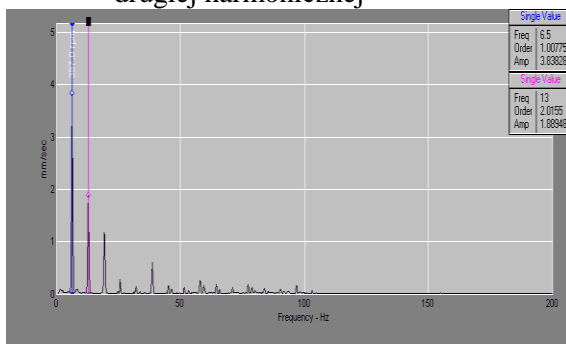
Fig. 12. The peak at crusher speed frequency (at 6.5 Hz) in axial direction of rotor bearing, NDE, after repair

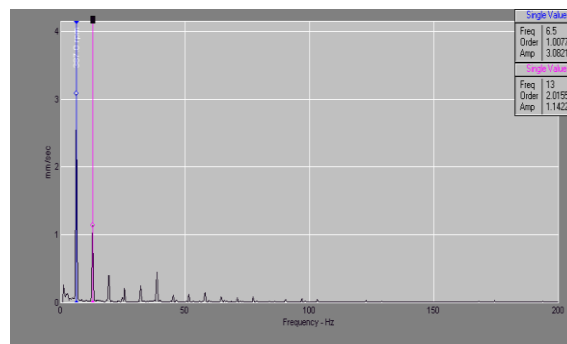
3. In Fig. 13 and Fig. 14 are spectrums for DE and Fig. 15 and Fig. 16 are spectrums for NDE in horizontal direction. The changes of amplitudes at crusher speed frequency are very small.

Fig. 13. The crusher, spectrum in horizontal direction of rotor bearing, DE with harmonics, failure

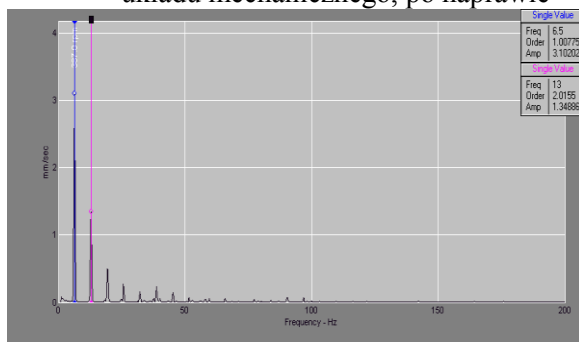
Fig. 14. The crusher, spectrum in horizontal direction of rotor bearing, DE with harmonics, after repair

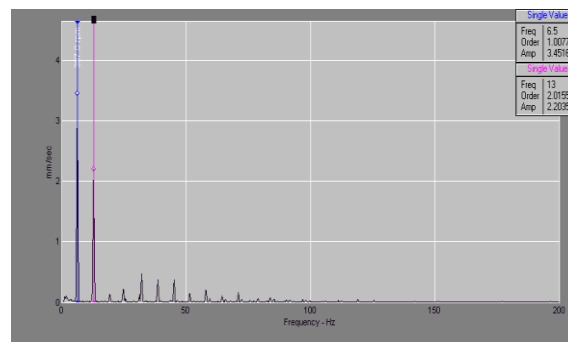
Fig. 15. The crusher, spectrum in horizontal direction of rotor bearing, NDE with harmonics, failure

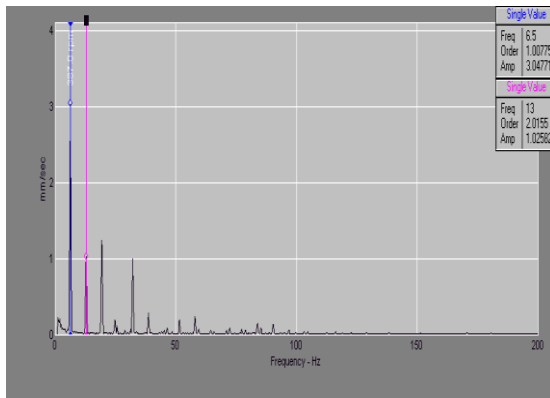
Fig. 16. The crusher, spectrum in horizontal direction of rotor bearing, NDE with harmonics, after repair

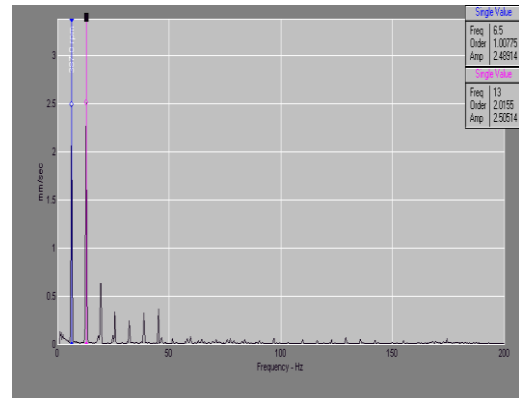
4. In Fig. 17 and Fig. 18 are spectrums for DE in vertical direction. The change of amplitude at crusher speed frequency is very small too.
5. The measurement of phase at crusher speed frequency was done too. These results served to completion information about considered failure of crusher. The results are in Tab. 1. These results can be interpreted as follows.

Fig. 17. The crusher, spectrum in vertical direction of rotor bearing, DE with harmonics, failure

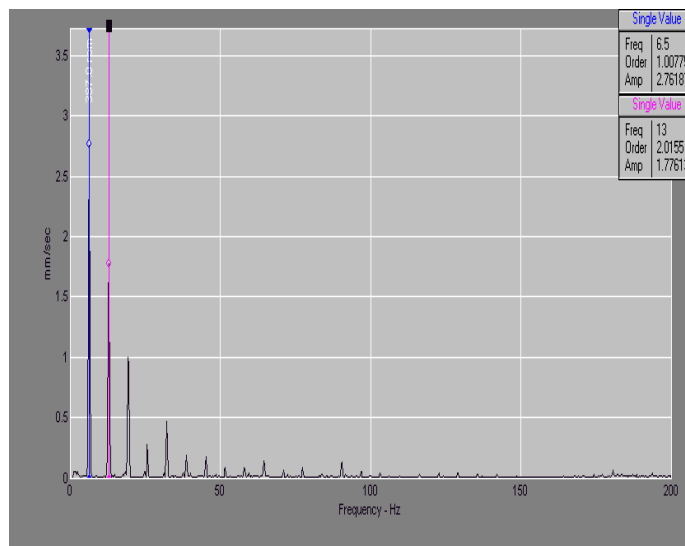
Fig. 18. The crusher, spectrum in vertical direction of rotor bearing, DE with harmonics, after repair.
