IDENTIFICATION OF TECHNICAL STATE AND OPTIMISATION OF OPERATION OF TRANSPORT-HANDLING EQUIPMENT

Summary. This paper describes a real example from the practice concerning an analysis of technical state and operational optimisation of the given transport-handling equipment, which is installed in a trans-shipment station specified for transport and handling of bulk materials. By means of identification of a faulty technical state of this transport equipment there was determined the main cause of a damage process, which occurred during current operation. Consequently, it was possible to perform an optimisation of the relevant technical parameters in order to eliminate the negative phenomena.

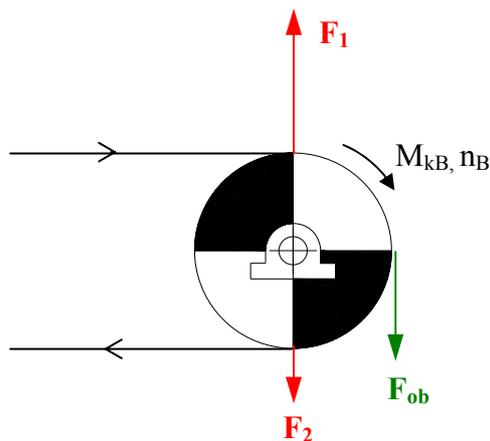
Fig. 1. Force situation on driving pulley

Thus, the maximum permissible force F_{max} in the belt is 350 000 N. So it is evident that $F_{max} \gg F_1$ thanks to high level of tension safety coefficient of belt. The belt is over-dimensioned more than six-time and its tensile strength is sufficient enough.

However, according to eccentric wear of running surface of belt, which is in permanent contact with guiding cylinders, it can be expressed a judgment about negative impact of “dumbbells” misalignment on the belt loading (i.e. additional eccentric loading).

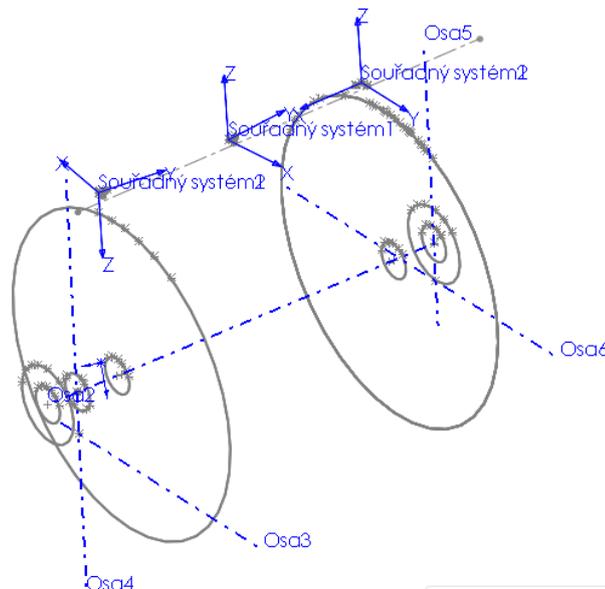
Fig. 3. Display of measured data from the equipment 3D Creator
Rys. 3. Przedstawienie wartości zarejestrowanych przez urządzenie 3D Creator

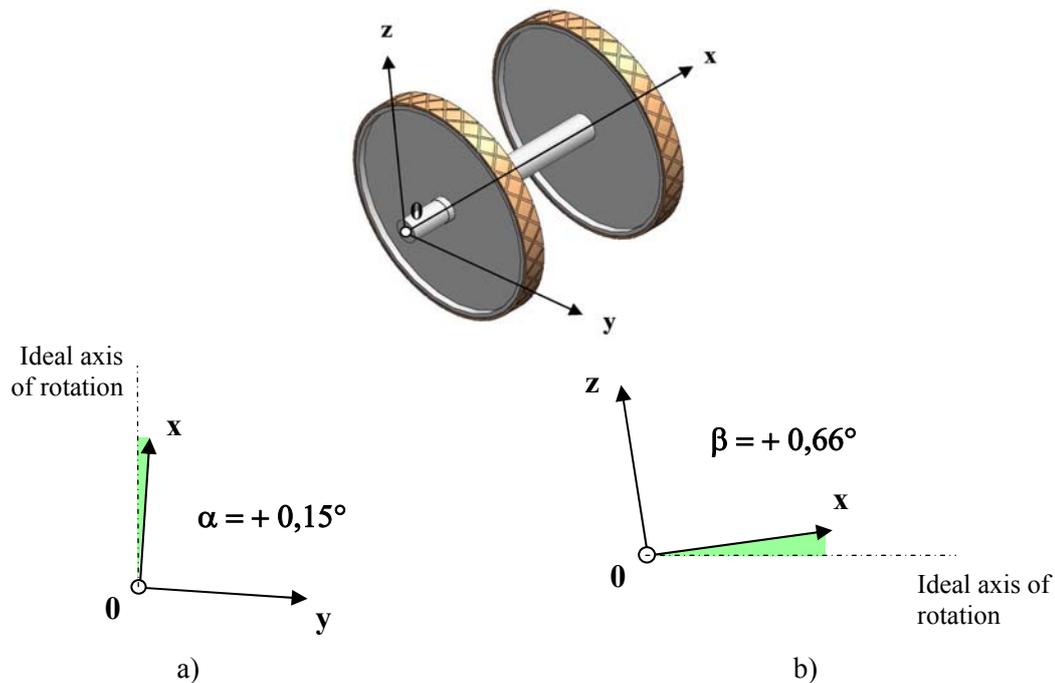
Fig. 4. Measured angular deviations: a) angular deviation in horizontal plane, b) angular deviation in vertical plane

According to the measured data there was identified a relevant deviation in the vertical direction. This deviation value was 23 mm of the height difference between the bearing houses.

The visual inspection of the running surfaces of the guiding cylinders corresponds with the results obtained from measured of the conveyor geometrical disposition. The wear out of the guiding cylinder running surfaces was eccentric due to an incorrect geometry of the guiding cylinders set-up.

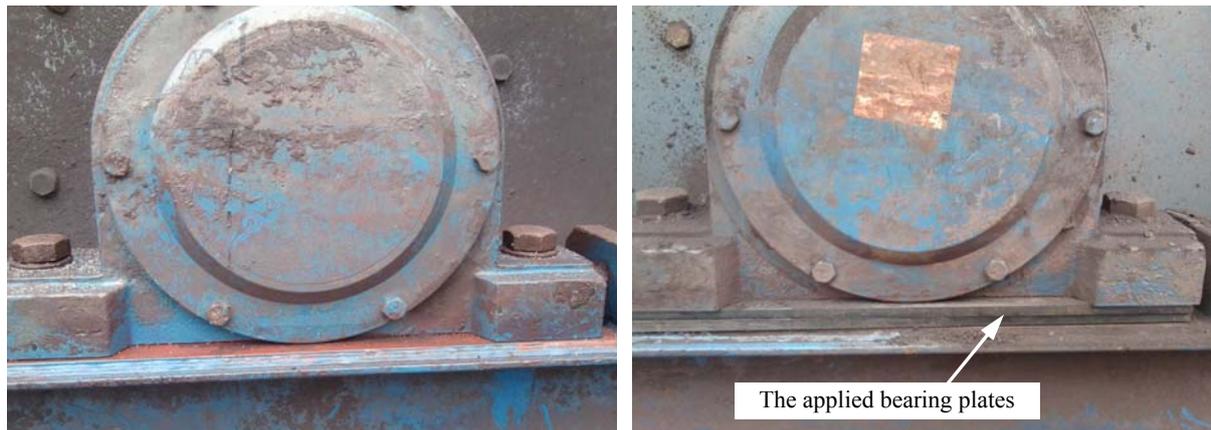
Fig. 5. Elimination of the angular deviation in the vertical plane

Finally, it is possible to say that the chosen measuring methodology, together with the applied measurement equipment, was very effective for solving of the given task. According to the measured values of the angular deviations the original geometrical position of two guiding cylinders was corrected by means of bearing plates that were placed under the bearing houses, Fig. 5.
