Świątoniowski, A., Szostak, J., Chodorowska, D. Repair technology of the composite wing of a light-plane damaged during an aircraft crash. *Scientific Journal of Silesian University of Technology. Series Transport*. 2016, **92**, 149-157. ISSN: 0209-3324.

REPAIR TECHNOLOGY OF THE COMPOSITE WING OF A LIGHT PLANE DAMAGED DURING AN AIRCRAFT CRASH

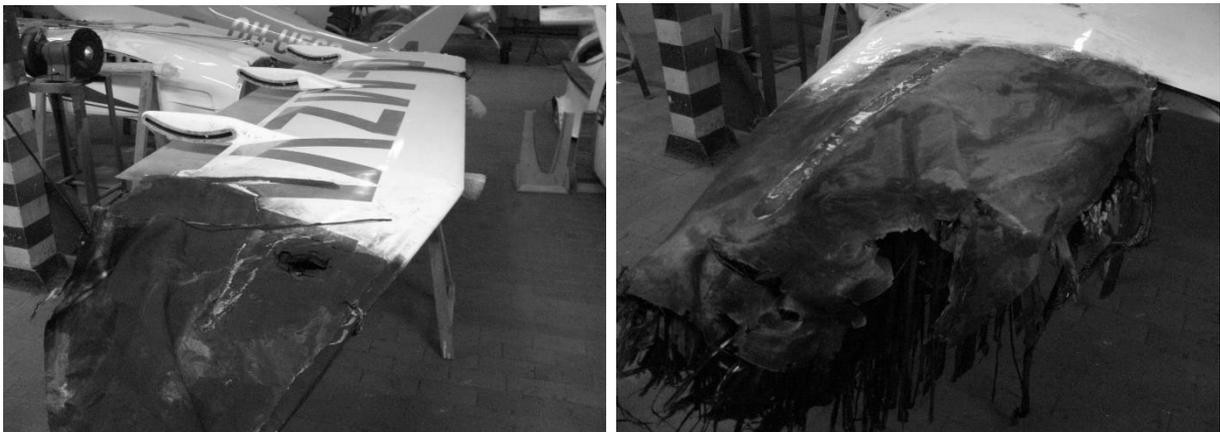
The damage in question affected the front part of the fuselage (manufactured entirely of fibreglass and carbon fibres with the application of “sandwich” technology and possessing a honeycomb structure core), the front undercarriage and the wings on a 9 m wingspan. The left wing, of which 1,760 mm was burnt together with the main spar, and the aileron could no longer be repaired (Fig. 1).

Fig. 1. View of the fragments of the left wing of a UL plane burnt in an aircraft crash involving another UL plane (irreparable)

The reason for this was that it was impossible to reconstruct the main spar in such a way that its initial design strength would be restored.

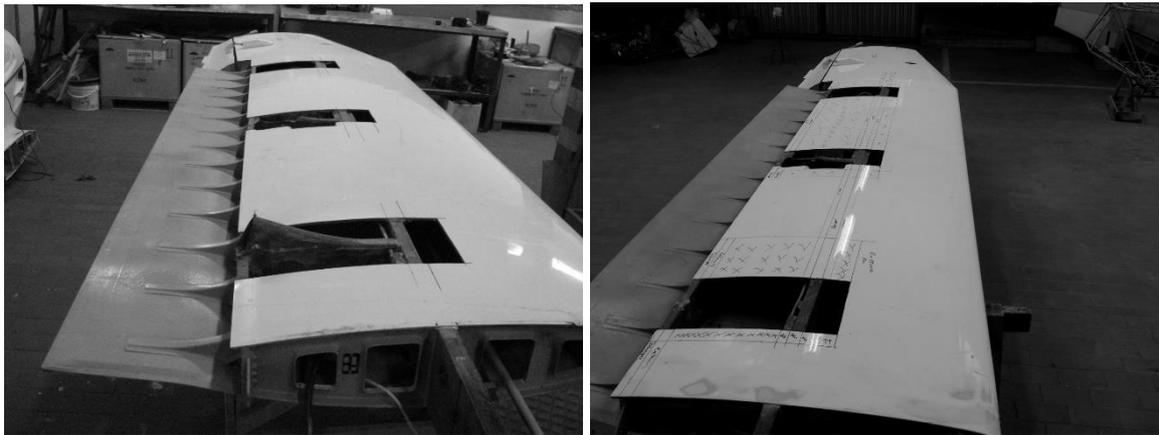
After a detailed analysis, however, it was found that such a repair may be conducted on the right wing, in which the boom ribs were broken, while the Fowler flap protracting mechanism, which contained the right high-lift device, as well as the end of the wing, was destroyed.

Fig. 4. View of the wing in the course of repair work

The wing repair was commenced by cutting out a fragment from its bottom shell plating, which was 120 mm on each side of the damaged rib no. 1, in order that it could be cut out with the application of a rotary saw.

This operation was repeated on ribs nos. 2 and 3 (Fig. 4), although there was an additional difficulty due to the fact that those ribs constituted the side panels of the fuel tank, which was inseparably connected to the construction of the wing, as shown in Figure 5.

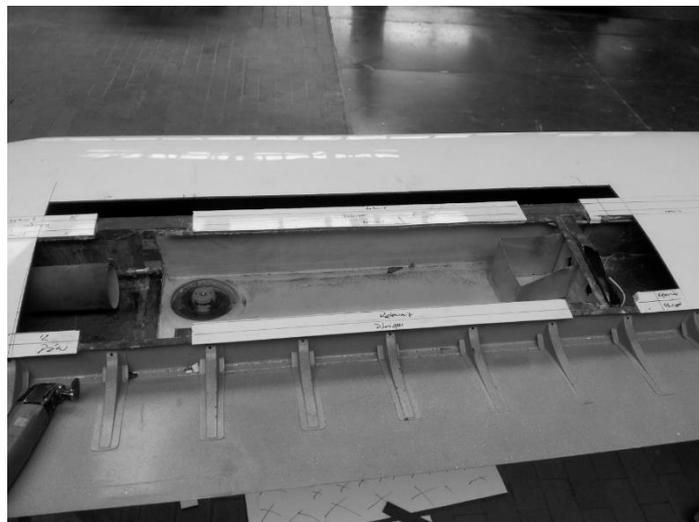
Fig. 5. Fragment of a fuel tank constituting the inseparable part of the wing construction

The side surfaces of ribs nos. 2 and 3, constituting the side surfaces of the fuel tank (Fig. 5), were subjected to lamination. For that purpose, a composite based upon a fibre made of S-type glass, impregnated with epoxy resin, whose tensile strength amounts to $\sigma_r = 882$ MPa, and fuel resistant was applied. This step was also repeated on the remaining surface

of the tank, with the surface in question subsequently covered with the TAPOX 2-k Epoxy sealant, made by Fertan.

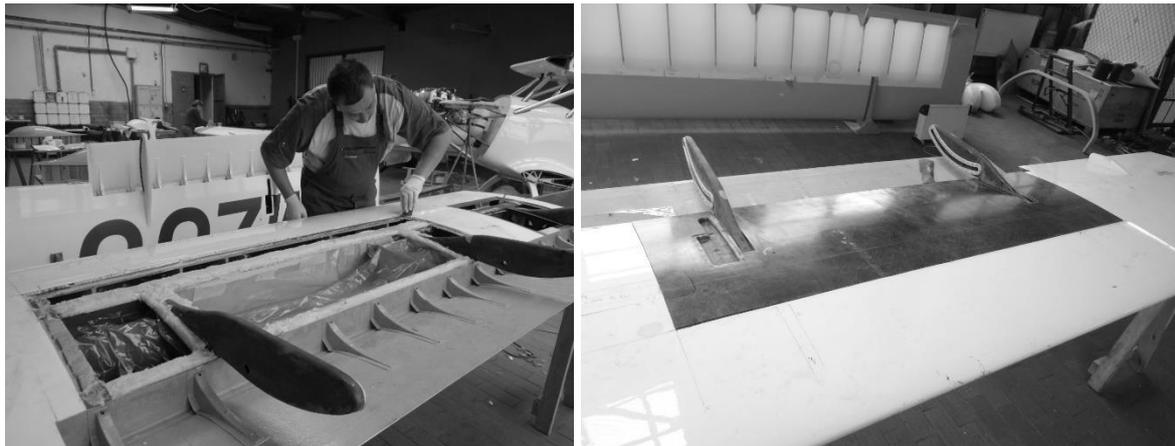
Fig. 6. Shell plating mounting operation with the application of the adhesive, as well as the view of the right wing after its new fragment was mounted with the use of the adhesive

For that purpose, in the place of connection between the old and new elements of the wing shell plating (at a width of 40 mm), the layer of the composite made of carbon fibre was removed, as was the Nomex⁵. The purpose here was to make it possible to conduct “overlap” fastening with the adhesive of the new shell plating bands, which were adjusted to the holes cut out of the wing (Fig. 6).

In the course of the work, particular attention was devoted to removing the excessive quantity of the adhesive (flashes) in the place of connection between the shell plating (Fig. 6), which, after the resin has dried, facilitates grinding and preparing 60 mm surface bands, on which the strengthening elements of those edges are laminated.
