## DESTRUCTION MECHANISMS OF CU-ETP COPPER GUIDES FOR SECTIONAL INSULATORS OF RAILWAY TRACTION

**Summary.** This article presents the results of a research on the operational damage to sectional insulator guides made of hard electrolytic copper Cu-ETP (Electrolytic Tough Pitch Copper). The guides were used on various rail routes, in real conditions, on which the trains ran at maximum speeds between 40 and 120 km/h for periods of 6 or 12 months. The microstructure of the surface, the working layer of the guide, which contacts the graphite plate of the current collector and the cross-section of the guide in the place where it was damaged was examined using the Olympus light microscope. The analysis of the chemical composition in the EDS micro-regions was performed using the Zeiss Supra 53 scanning electron microscope (SEM), while the qualitative X-ray phase analysis was performed with the use of the Panalytical X'Pert diffractometer. Scratches and deformations of the surface layer characteristic of the phenomenon of friction caused by the current collector were observed in the microstructure of the damaged parts of the guides of section insulators. The effect of a very intense oxida

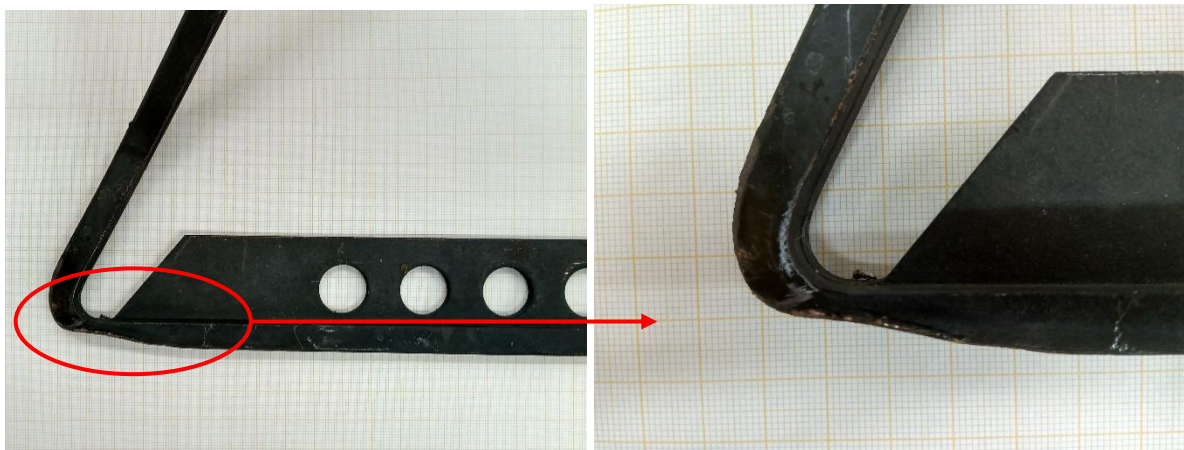
Given the observations on a macro scale, it was found that the greatest wear, as well as the deformation of the working surface, occurred in the immediate vicinity of the beginning of the arcing horn of the guide (Figure 1).

Fig. 1. Guide of the section insulator at the beginning of the horn extinguishing an electric arc. a) a new unused element; b) an element operated with a visible defect

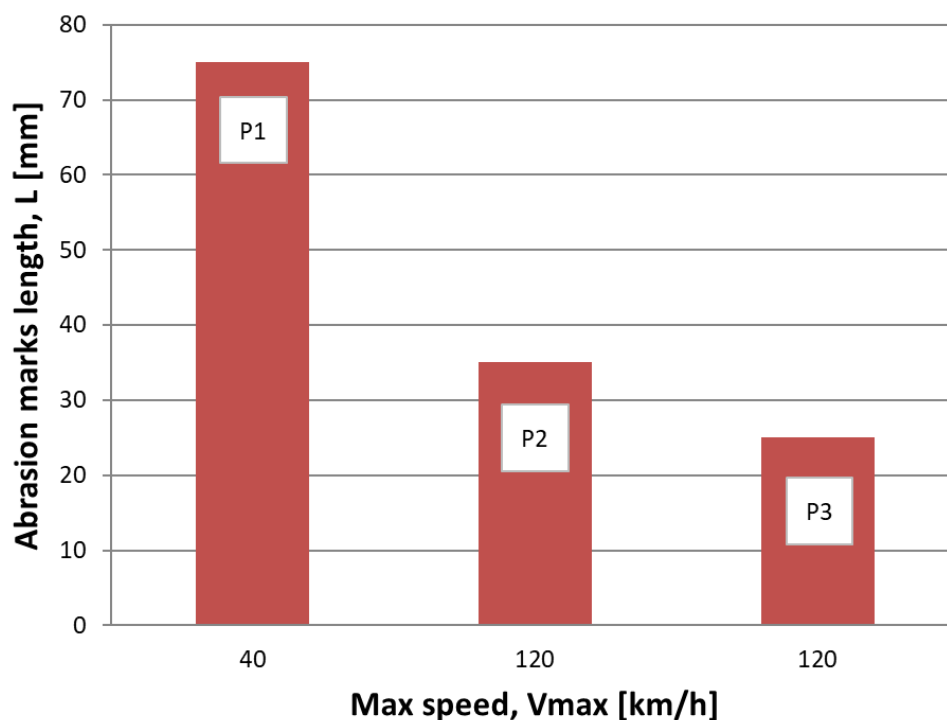
Given the measurement of the length of the abrasion marks on the guides of the section insulator, it was found that with the increase in vehicle speed (current collector), the length of the marks decreased. For the maximum speed of 40 km/h (the guide used for 12 months), the length of the abrasion mark is 75 mm (P1), for the speed of 120 km/h (the guide used for 12 months), it is 35 mm (P2) and for 120 km/h (the guide used for 6 months), it is only 25 mm (P3) (Figure 2).

The relation shown in Figure 2 can be explained by the fact that the sliding speed is an important parameter influencing the process, which takes place between the copper-graphite elements. As it results from the research [9], both the friction coefficient and the degree of wear increase at low speeds. Increasing the sliding speed to moderate speeds reduces the friction, and consequently, the wear decreases.

Fig. 2. Change in the length of the abrasion marks on the guide depending on the maximum speed of the locomotive, P1 - 40 km/h, 12 months, P2 - 120 km/h, 12 months, P3 - 120 km/h, 6 months

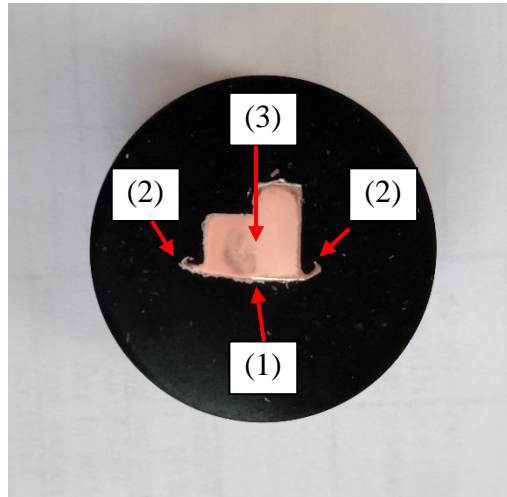
The guide which had been damaged as a result of operation was cut and a cross-section was mounted in the epoxy resin (Figure 3). Considering the macroscopic observations, it was found that the working surface of the guide, due to exploitation, was worn and formed in a shape of a so-called 'cradle' (1). On both sides are visible 'whiskers' (2) – made by plasticised material of the guide and then by the pressure of the current collector.

Fig. 3. Cross-section of the guide in the area marked in Figure 1B

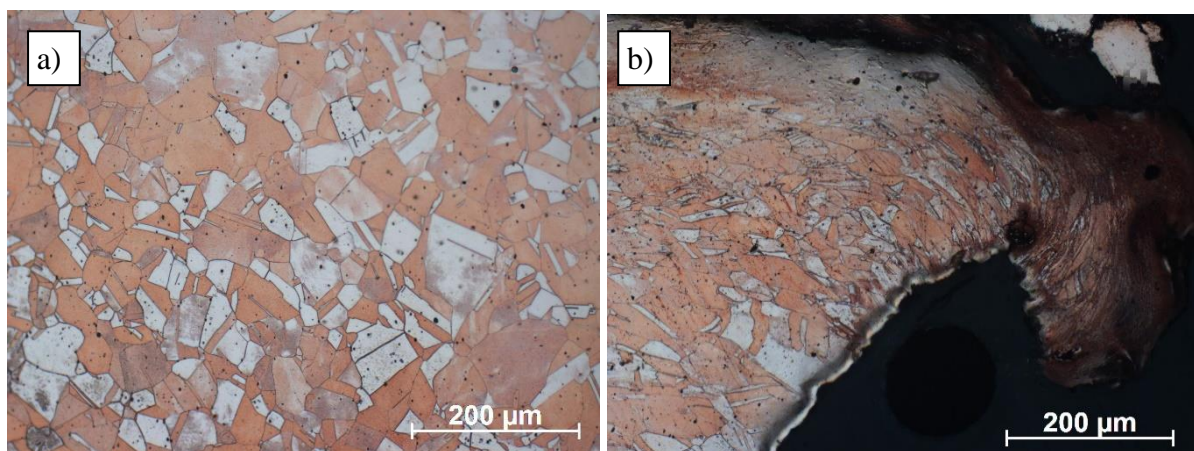
The microstructure in the area of the geometric centre of the cross-section (3) and the deformed 'whiskers' (2) are shown in Figure 4. Figure 4a shows the microstructure of copper, which is characteristic of a non-plastically deformed material with a predominant amount of equiaxed grains, with a shape similar to a sphere. Figure 4b shows the microstructure grains with an elongated shape close to axial, showing the mechanism and direction of the deformation. The average grain size (diameter) of the microstructure shown in Figure 4a is  $14.9 \mu\text{m}$  with a standard deviation of  $6.2 \mu\text{m}$  (41.6% of the average value), whereas,

for the microstructure shown in Figure 4b, it is  $7.1\ \mu\text{m}$  with a standard deviation of  $4.3\ \mu\text{m}$  (60.5% of the average value). The presented data show that the plastic deformation in the 'whiskers' (2) resulted in a reduction of the grain size by over 50%, and the increase in the value of the standard deviation indicates an increasing difference in grain size.

Fig. 4. Microstructure of the cross-section of the Cu-ETP copper guide; a) central area of the section; b) deformed 'whiskers'

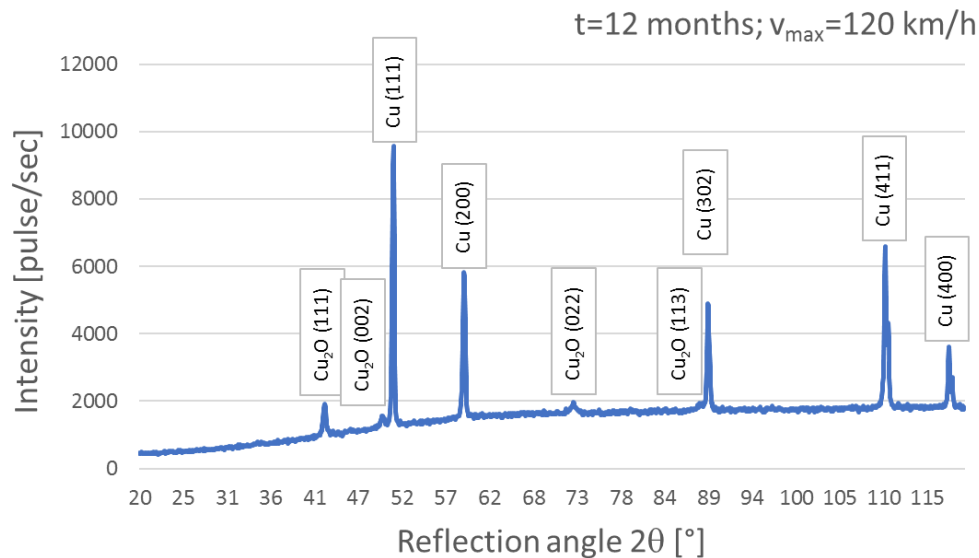
prove that during the operation of the guide, copper oxide was released on its surface. This is because the flow of electric current produces a thin layer of oxides, which may also play a positive role as a lubricant on the contact surface [9, 12]. The thin oxide layer formed on the contact surface excludes direct contact and reduces the adhesion between the elements. According to some scientists [13, 14], the oxide layer formed by the electric current on the contact surface of mating elements plays a major role in reducing the coefficient of friction. However, the authors [10, 15, 16] suggest that the flowing electric current works as a lubricant in the pulling process at constant parameters.

Fig. 6. Diffraction pattern of the guide after 12 months of operation on the route with a maximum train speed of 120 km/h

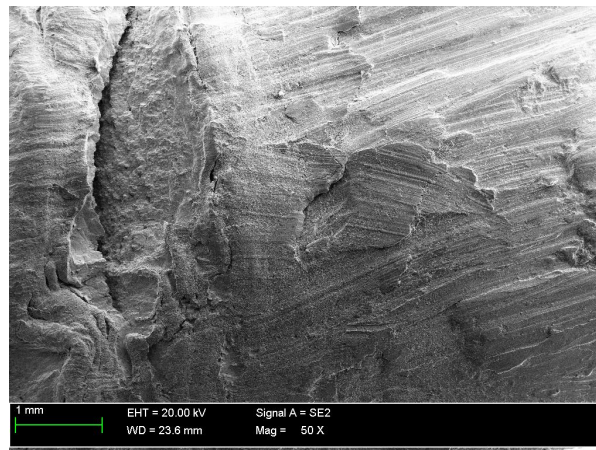
Thereafter, the microstructure of the guide's working surface was examined using a scanning electron microscope. The examination revealed abrasion marks visible on the surface caused by sliding and friction of the current collector on the surface of the guide during operation. The scratch lines are visible in the photo and run from left to right (Figure 8) following the working direction of the pantograph. An area of the base material was also noticed, which was torn off as a result of exploitation, and then, due to successive slides of the pantograph (current collector), glued/pressed with the guide base material in the contact place. A detachment of the base material due to friction was also observed in [10].

The detachment of a part (volume) of the material may also be caused by the plastification of the material due to a sudden increase in temperature from an electric arc. Because the pressure force of the current collector is not big enough to cause the effect shown in Figure 8 without the influence of temperature.

Fig. 8. Microstructure of the working surface of P2 sample (120 kph for 12 months)

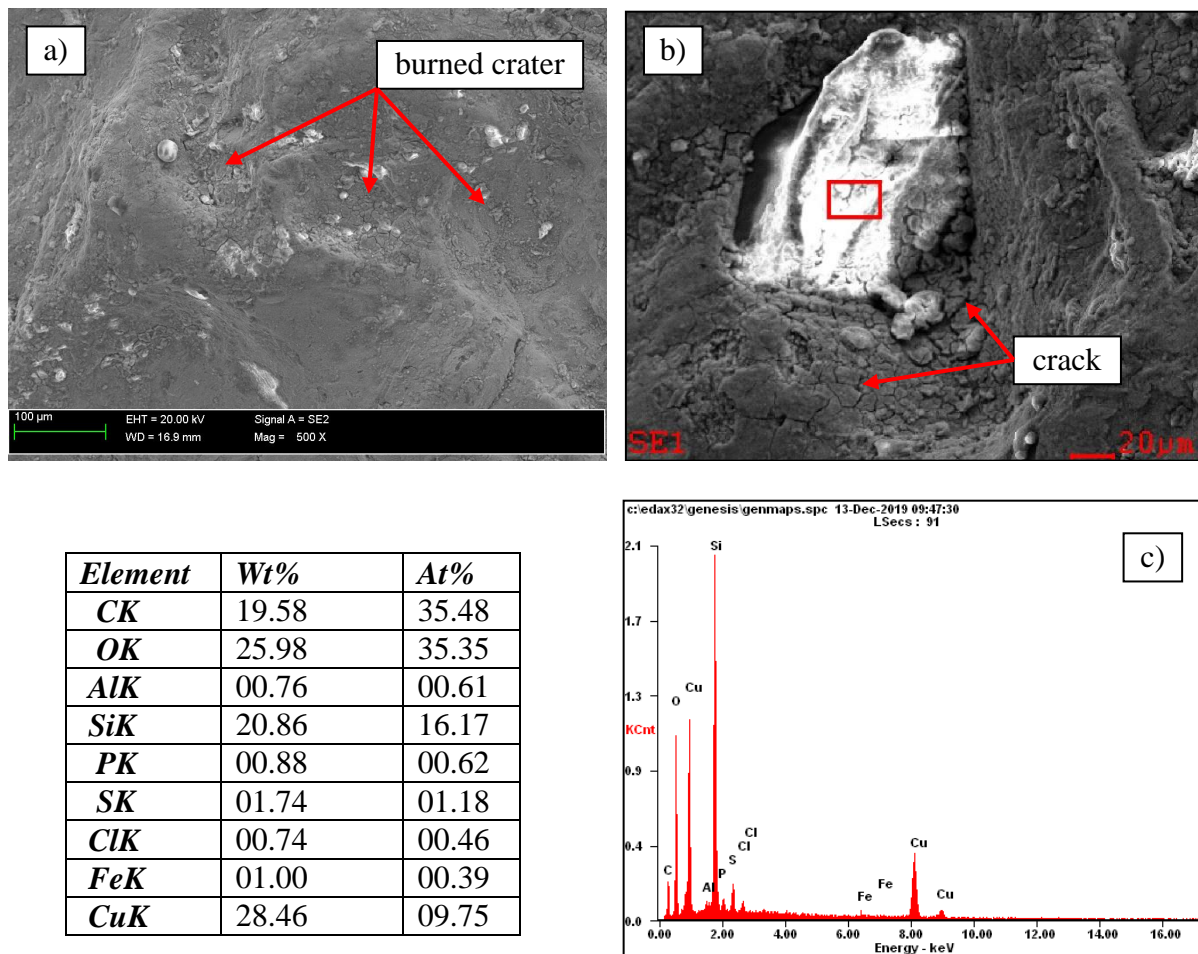
The next step in the analysis of the failure mechanisms of the section insulator guide was the analysis of intensity as a function of energy-dispersive X-ray spectroscopy (Figure 9). Burned craters were noticed in the microstructure of the surface of the guide. The analysis of the chemical composition in the micro-areas confirmed the presence of carbon, oxygen, silicon and copper as well as small amounts of iron, sulfur, aluminium, phosphorus and chlorine (Figure 9c). A large amount of oxygen indicates the presence of oxides. The reason for such a large increase in oxides is most likely the phenomenon of an electric arc generated during the jump of the current collector between the guides of neighbouring sections of the railway traction. An arc usually occurs as a result of the distinct potential differences between the neighbouring sections. The temperature in the centre of an arc may rise to several thousand degrees Celsius [22]. The presence of oxides on the examined surface is evidenced by numerous bright areas in the photo (Figure 9a, b) caused by the lack of electrical conductivity of the electron beam forming the image in the electron microscope. The particle shown in Figure 9b can also be a grain of sand, which was pulled in the gust of the moving train, then got between the surfaces of the current collector, softened by the high temperature of the electric arc of the guide and finally pressed into the guide. The large increase in temperature also generated local melting of the basic material and its subsequent rapid cooling caused numerous stresses, leading to local cracks in the material of the guide (Figure 9b).

Fig. 9. Microstructure of surface of P2 sample (120 km/h for 12 months) (a, b) and analysis of the chemical composition of the marked area (c)

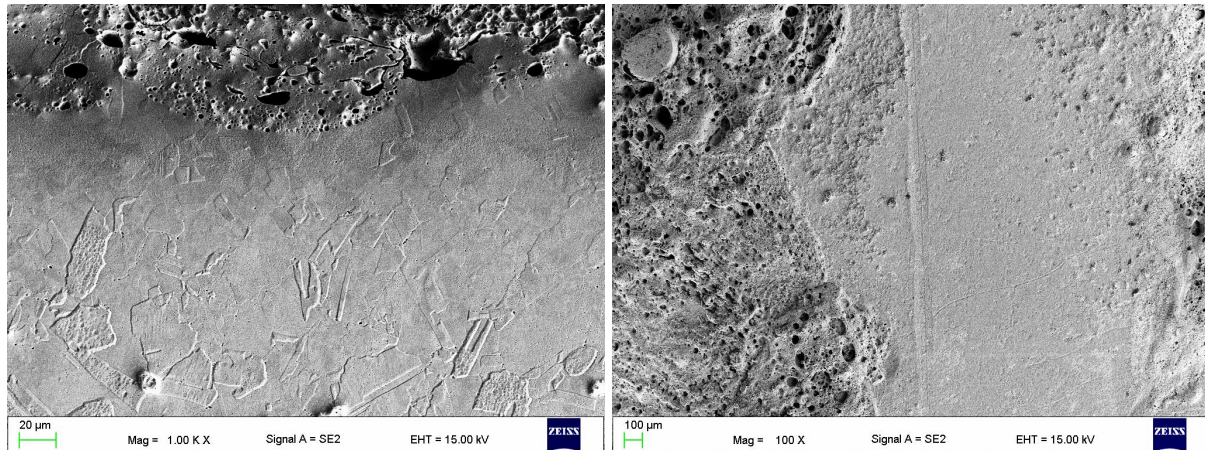
The effect of an electric arc on the copper guide is shown in Figure 10. In the upper part of the guide's cross-section (Figure 10a), a melted area of the material is visible, whereas, below there is a transition zone and then the microstructure of the Cu-ETP guide. Some grains are visible in the microstructure.

Figure 10b, which is a top view of the guide's working surface, on the left can be seen a melted area and on the right side, there is a groove carved by the current collector. The geometrical features of the groove indicate that it could have been carved by foreign particles, that is, sand grains that got between the working surface of the guide and the current collector. The melted layer of the vitrified material of the guide is interspersed with holes from which gases escaped during melting. The nature of these damages clearly indicates surface erosion caused by an electric arc. A negative effect, which an electric arc has on the elements of the railway traction, is the significant porosity of the melted metal. The pores can be penetrated by pollutants or water from precipitation, which may constitute local corrosion centres. Moreover, the metal melted in such conditions is characterised by unfavourable mechanical properties and reduced resistance to frictional wear. As earlier indicated, the oxide layer grows to a critical thickness, and then separates from the base material, revealing a non-corroded material layer, which may oxidise again [21].

Fig. 10. Microstructure: (a) of the cross-section of the guide,  
(b) of the working surface of the guide
