Grega, M., Brezinová, J. Causes of stress-relief cracks in forged differential gear. *Scientific Journal of Silesian University of Technology. Series Transport*. 2025, **128**, 83-94.
ISSN: 0209-3324. DOI: <https://doi.org/10.20858/sjsutst.2025.128.5>

CAUSES OF STRESS-RELIEF CRACKS IN FORGED DIFFERENTIAL GEAR

Summary. The article investigates the formation of stress-relief cracking and lamellar cracking in steel forgings used for differential gears for transport components. The forging and heat treatment processes, conducted under consistent technological conditions, revealed the occurrence of carburizing annealing cracks caused by plasticity depletion during stress relaxation. Additionally, stress-relief cracks were microstructurally analyzed, and the primary cause of the disturbance of the equilibrium state, which resulted in the formation of these cracks, was sought. Die-tool wear and damage during forging were identified as key contributors to the formation of non-metallic oxide inclusion, transferring surface defects and creating lamellar propagation during subsequent heat treatment. The findings underscore the influence of tooling conditions and process parameters on the qu

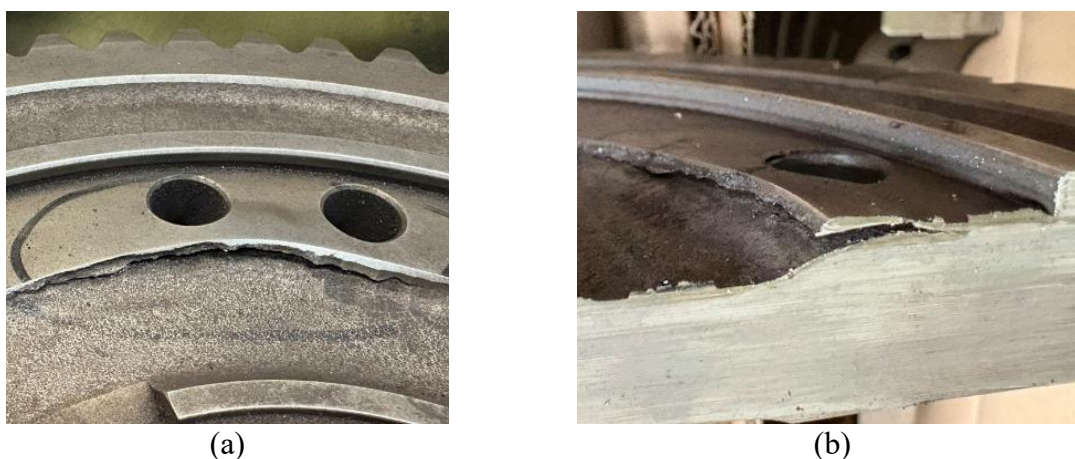
Fig. 2. Inspected forging in visual testing (VT): a) Location of cracks on forging;
b) Location of cracks on forging in section

The cracks are localized on the bottom and upper sides of the forging (Figure 3, zones A and B). The length of the cracks ranged from 40 to 120 mm (Figure 2a,b). The depth of this crack ranges from 0 to 15 mm. These cracks were observed only in special zone with radius R6 mm in part of its perimeter. The start of the crack (Figure 2a) is on surface R6, and progression is lamellar toward the outer side (Figure 2b) of the forging.

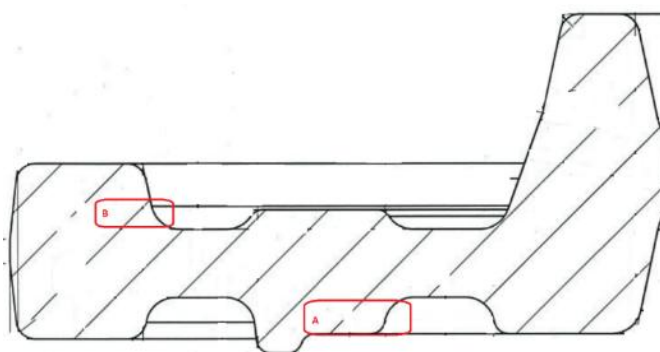
Fig. 3. Localized crack after VT only in two zones, A and B (red color on section scheme)

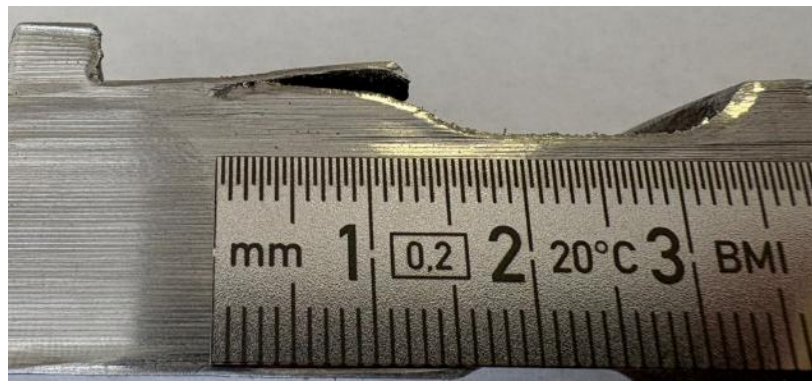
Fig. 4. Length crack in zones A

The direction of the cracks is parallel to the surface of the hardened layer. On macroscopic observation of the crack – Fig. no. 4 and 5, an oxide layer is clearly visible along its entire length. The crack starts in the martensitic structure and runs and ends in the bainite microstructure - boundary zone. The start of the cracks is on the surface at a radius of R6, on the forgings.

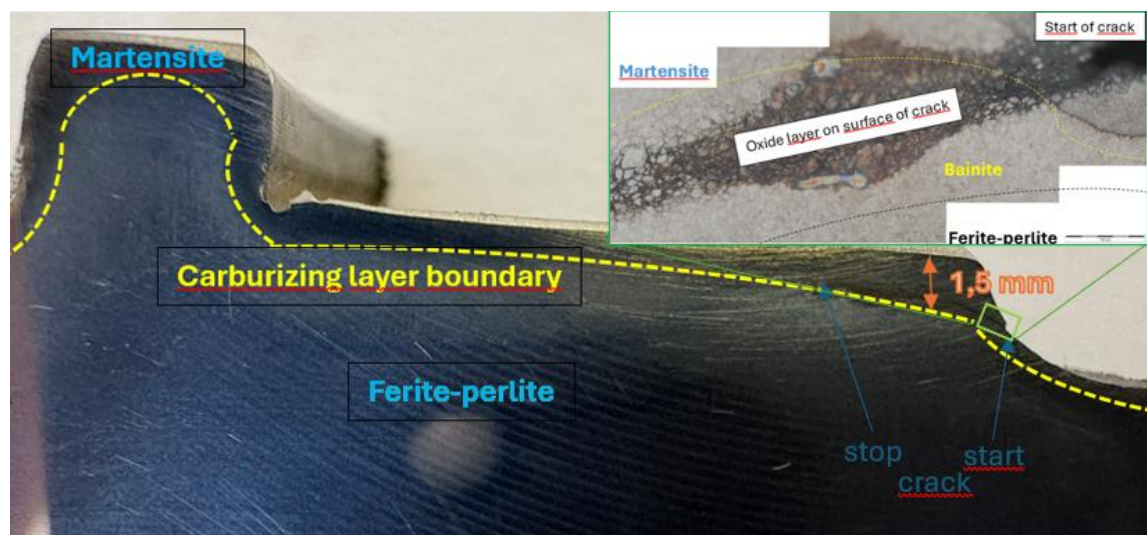
Fig. 5. Macroscopic observation of the steel structure

The crack is bounded along its entire length by an oxide layer (Figure 5 up), beneath which a gradual intergranular breakdown of the bainitic structure is observed.

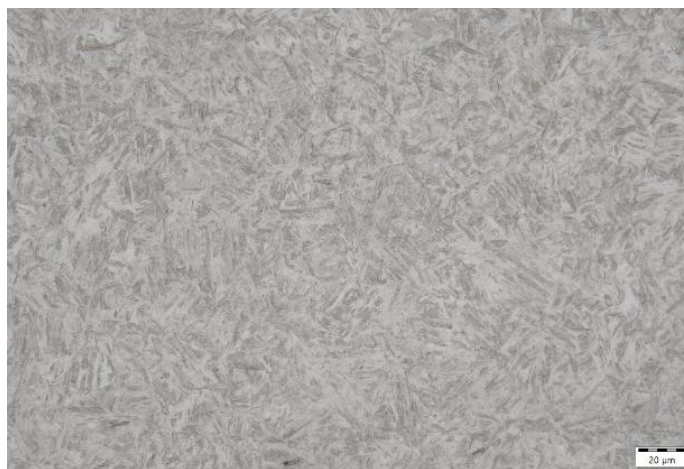
- Border zone – Upper Bainite (Figure 7) is the transition region between the hard case and the softer core. The microstructure consists primarily of columnar and equiaxed bainitic laths, which nucleate intragranular due to the presence of non-metallic inclusions. These grains are randomly oriented, providing isotropic mechanical properties. The lath-like morphology is characteristic of transition zones cooled at moderate rates, which prevents the formation of coarse pearlite or martensite. This gradient zone results from decreasing carbon content and a reduced cooling rate with depth. It exhibits a mixed microstructure comprising:
 - upper bainite, which appears darker and more compact;
 - acicular ferrite with minor polygonal ferrite;
 - in this zone oxide inclusion are observed.

Fig. 7. Microscopic observation of the borderline structure – bainite

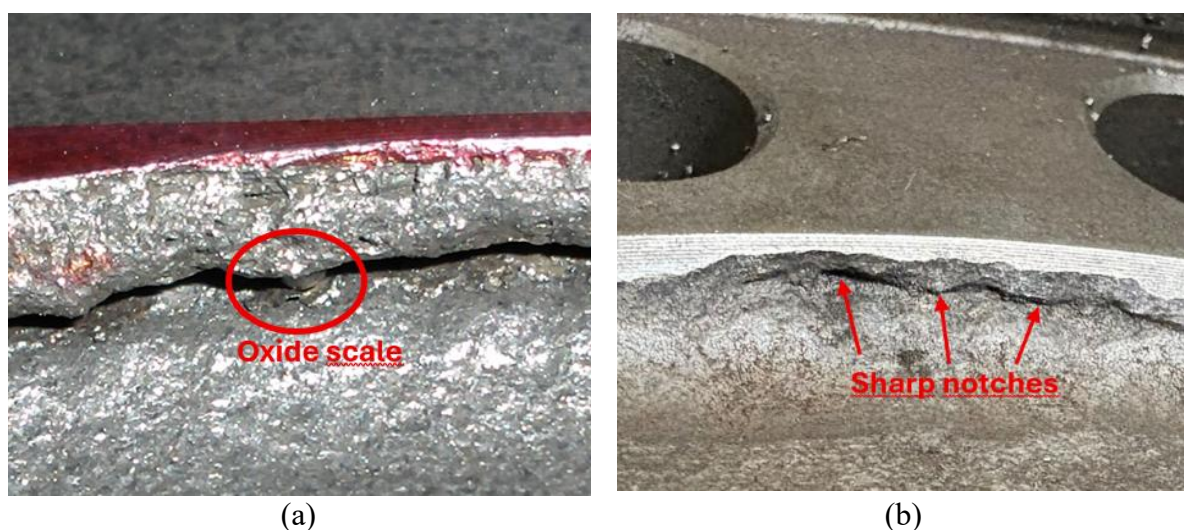
A detailed visual examination of the crack (Figure 9a, b) on the surface of the forging revealed that it was formed by sharp notches that penetrated the surface layer at radius R6 and thus disrupted its integrity. The inclusion material consisted of oxide scale residues that had entered the layer of the base material during forging. The shape of the oxide scale is flaky, and when mixed into the surface of the steel forging, a surface groove is created. The oxide scale was removed from the surface of the forging during the blasting operation, but traces remained in the form of notches and grooves.

Fig. 9. Detail from a visual inspection of initial cracks on the surface:
(a) oxide scale in radius R6; (b) sharp notches on the surface

It is important to note that these stress-relieving cracks are only a consequence of the introduction of oxide inclusions into the surface of the forging and thus the creation of a notch concentrator of excess stress during the forging process in the austenitic phase [9]. The places of introduction of oxide inclusions are defined in two specific zones of the forging in local radii on the upper and lower parts of the forging. It should be noted that the material flow in the forging process causes abrasive wear of the dies, which, if not properly maintained, can cause a reduction in the radius of the radii and thus the formation of a place where oxide inclusions occur more frequently. Oxide inclusions are subsequently transferred from the die to the forging when the material in the austenitic phase does not flow properly. Mold failure in hot forging is complicated by various types of influencing variables, such as mold material, mold design, mold manufacturing, and forging operations [1]. Structural disharmony together with the notch effect on the surface of the forging leads to the formation of microcracks, which act as precursors to crack formation in the following heat treatment.
