## DESTRUCTION MECHANISMS OF CU-ETP COPPER GUIDES FOR SECTIONAL INSULATORS OF RAILWAY TRACTION

**Summary.** This article presents the results of a research on the operational damage to sectional insulator guides made of hard electrolytic copper Cu-ETP (Electrolytic Tough Pitch Copper). The guides were used on various rail routes, in real conditions, on which the trains ran at maximum speeds between 40 and 120 km/h for periods of 6 or 12 months. The microstructure of the surface, the working layer of the guide, which contacts the graphite plate of the current collector and the cross-section of the guide in the place where it was damaged was examined using the Olympus light microscope. The analysis of the chemical composition in the EDS micro-regions was performed using the Zeiss Supra 53 scanning electron microscope (SEM), while the qualitative X-ray phase analysis was performed with the use of the Panalytical X'Pert diffractometer. Scratches and deformations of the surface layer characteristic of the phenomenon of friction caused by the current collector were observed in the microstructure of the damaged parts of the guides of section insulators. The effect of a very intense oxida

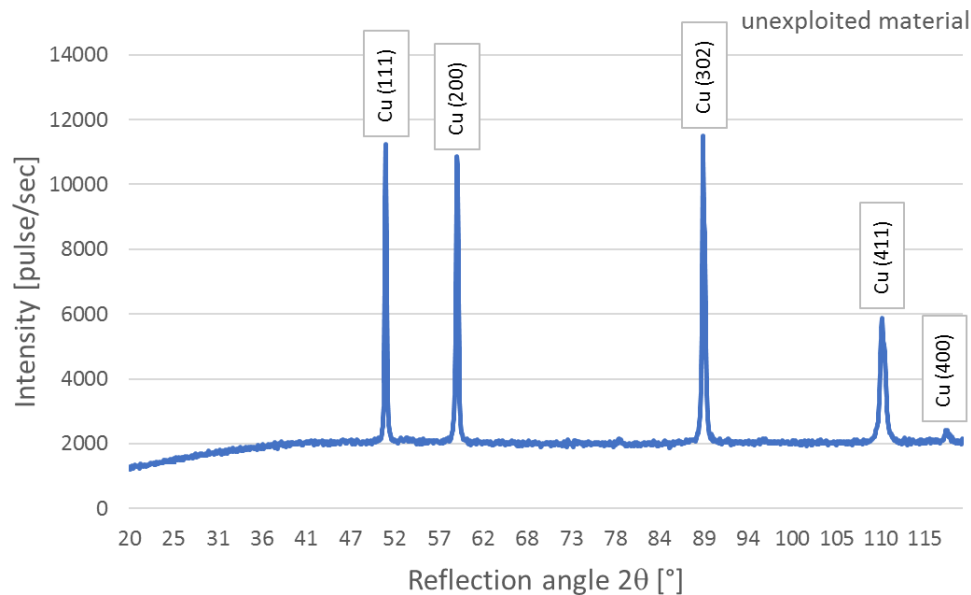
In the structure of the material of a new guide of the section insulator made of Cu-ETP copper (Figure 5), only the presence of copper was confirmed based on the qualitative X-ray phase analysis, which was expected. However, in the case of a guide that had been used for 12 months on a railway line, where the trains travelled at the maximum speed of 120 km/h, apart from copper, the presence of copper oxide  $\text{Cu}_2\text{O}$  was found (Figure 6), which was confirmed by the reflections from the planes (111), (002), (022) and (113) of this phase. These results

Fig. 5. Diffractogram of a new guide
