Grega, M., Brezinová, J. Causes of stress-relief cracks in forged differential gear. *Scientific Journal of Silesian University of Technology. Series Transport*. 2025, **128**, 83-94.
ISSN: 0209-3324. DOI: <https://doi.org/10.20858/sjsutst.2025.128.5>

CAUSES OF STRESS-RELIEF CRACKS IN FORGED DIFFERENTIAL GEAR

Summary. The article investigates the formation of stress-relief cracking and lamellar cracking in steel forgings used for differential gears for transport components. The forging and heat treatment processes, conducted under consistent technological conditions, revealed the occurrence of carburizing annealing cracks caused by plasticity depletion during stress relaxation. Additionally, stress-relief cracks were microstructurally analyzed, and the primary cause of the disturbance of the equilibrium state, which resulted in the formation of these cracks, was sought. Die-tool wear and damage during forging were identified as key contributors to the formation of non-metallic oxide inclusion, transferring surface defects and creating lamellar propagation during subsequent heat treatment. The findings underscore the influence of tooling conditions and process parameters on the qu

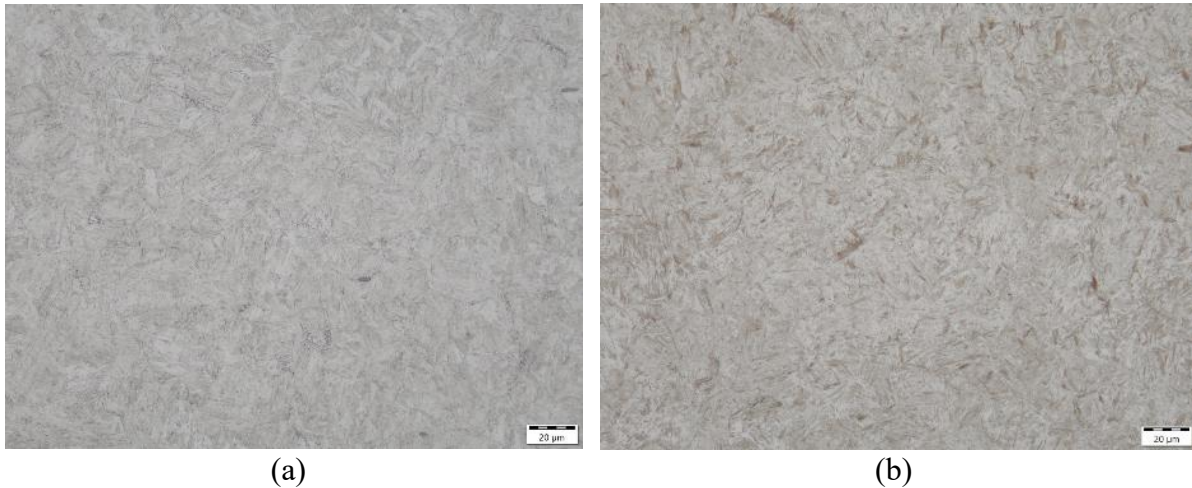
- The Core – Ferrite and Pearlite (Figure 6a) is the core microstructure of the steel, which remains unaffected by the carburizing and hardening treatments. It consists of a fine-grained ferrite-pearlite structure with evenly distributed phases. The light-colored ferrite matrix is interspersed with dark, lamellar pearlite colonies. This microstructure offers good toughness and machinability, although it has relatively low hardness compared to the surface.
- Surface Layer – Tempered Martensite (Figure 6b), which is a fine, needle-like structure typical of tempered martensite, which dominates the carburized and quenched surface layer. The structure appears uniform and relatively dense, with possible traces of retained austenite

in certain regions. The martensitic needles are tempered, indicating that the sample underwent a post-quenching tempering process. This microstructure is associated with high surface hardness and wear resistance, which is essential for the functional performance of case-hardened components.

Fig. 6. Microscopic structure (200x zoom):
(a) ferrite-perlite structure; (b) tempered martensite structure

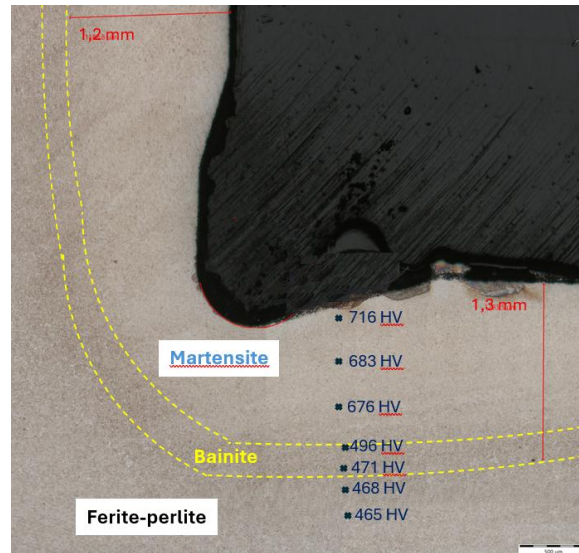
The combination of different microstructures across the case depth – tempered martensite at the surface, a martensite-bainite transition zone, and a ferrite-pearlite core – demonstrates the effectiveness of the applied thermochemical treatment in tailoring the performance of 18CrNiMo6-7 steel.

Fig. 8. Microscopic observation of the zone microstructure
