DAMAGES TO TURBINE ENGINE COMPONENTS

Summary. This article defines the typical damage to components of turbine engines, highlighting the differences between them and indicating possible causes. The distinction between various types of defects helps to explain the occurrence and supports personnel in defining the most suitable maintenance action to be performed. The defects described below are common in high-airflow turbine aviation engines on commercial and cargo aircrafts.

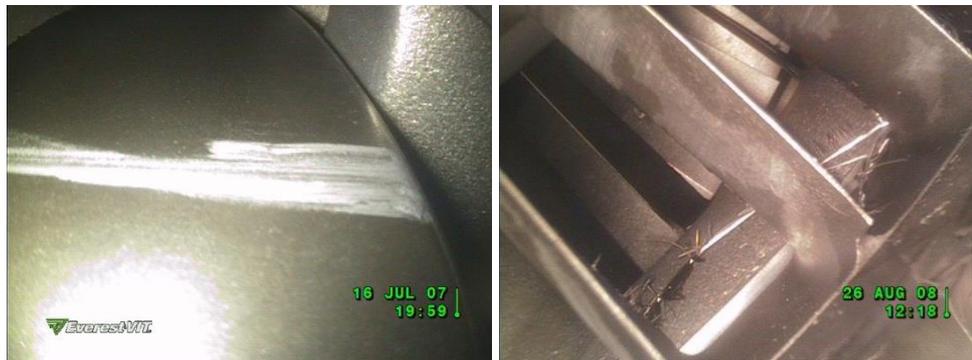
Fig. 1. Evidence of a bird strike

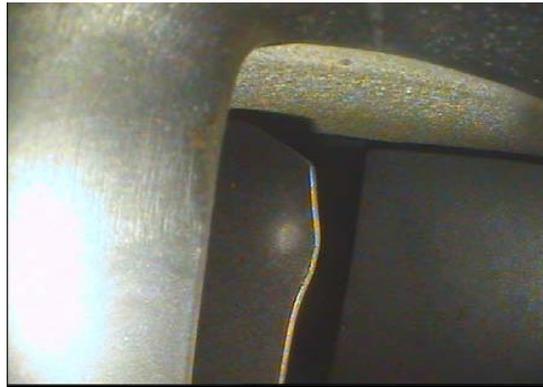
Fig. 2. Low-pressure compressor's trailing edge blade bend

An object is *bent* when the angular distortion from the original contour occurs. This damage is typical on leading and trailing edges of engine blades and caused by a lateral force. Such damage poses more danger to airfoil strength values than aerodynamics and, as such, bents are sometimes considered as dents by some manuals. In this scenario, it is to be measured in a lateral not an axial direction. A typical bend often appears on trailing edges as a result of foreign object impact. A large-scale bent in various dimensions is called *buckling*, which is caused by a foreign object or mechanical or thermal overload. An example of a trailing edge bend, which is to be investigated as a dent, is illustrated below.

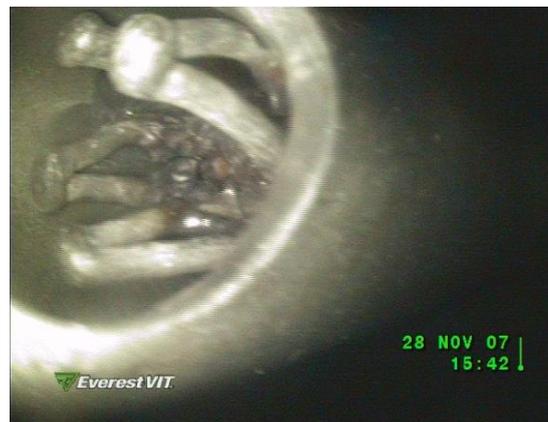
Fig. 3. Chromel-alumel thermocouple junction burnt

A *burn* refers to structural damage due to heat influence with no or improper protection, lubrication, clearance and shielding, or uneven temperature spread. It is accompanied by discoloration and, if not corrected, breaks the flow of material, which means the total loss of characteristics.

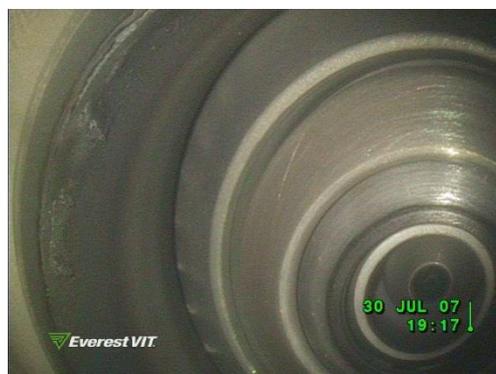
Fig. 4. Minor carboning on the fuel nozzle

Carboning refers to layers of carbon stocked on a material. Fuel nozzles are the parts of the engine where such a phenomenon most often occurs. This is the by-product of a combustion process, which is not often perfect. The area of accumulation is the result of fuel atomization, mixture swirling and low axial flow. Carboning of fuel nozzles is not a cause for rejection, provided it is not excessive. Excessive carboning will affect fuel spaying, which will further result in an uneven fuel/air mixture and stream temperature.

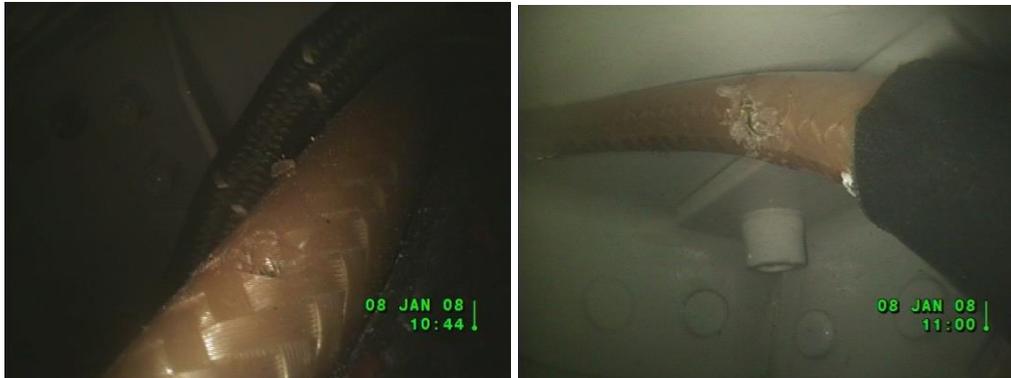
Fig. 5. Chafing between two adjacent cables due to insufficient separation

Chafing is typical description for the abrasion of two adjacent components, if at least one of them moves in a limited area against the other. This effect is often discovered between two tubes or pipes if they are not sufficiently separated from each other.

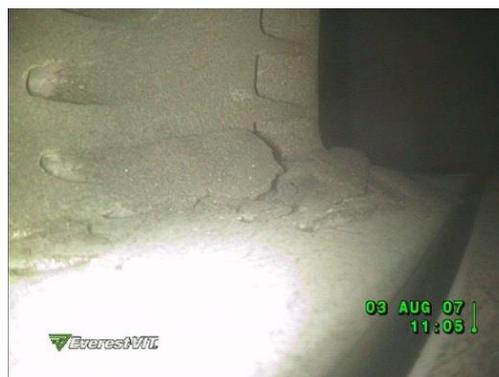
Fig. 6. Chunks of surface coating at the trailing edge of a high-pressure turbine blade

Chipping refers to the breaking away of small pieces under mechanical force, which is quite often an acceptable condition. This will result in local stress concentration due to material discontinuity. Contrary to flaking, chipping has a significant depth.

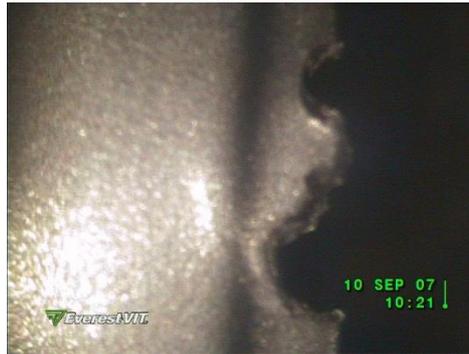
Fig. 7. Dents on a compressor blade's leading edge

A *dent* is a round-bottomed, smooth and shallow cavity, which results from impact or prolonged constant overload. Material is displaced, but not removed.

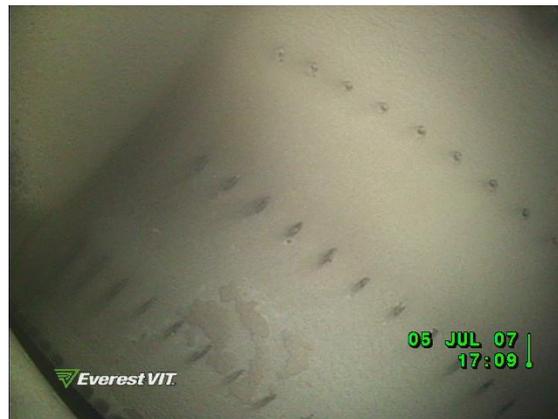
Fig. 8. Coating missing from the high-pressure turbine blade's concave side due to flaking

Flaking is the disintegration of paint or other external surface due to poor bonding or excessive load. An example of this deterioration is a when the coating flakes on high-pressure turbine vanes and blades. Due to high-temperature exposure, those airfoils are covered by bonding and ceramic coatings, which significantly increase the operational level of the blade by more than 100°. A bonding layer is an alloy of nickel, cobalt, chromium, aluminium and yttrium, while ceramic coating is a zirconia-stabilized yttrium oxide. The bonding layer produces oxide when exposed to high temperature and is porous enough to accommodate the outer zirconia layer, which decreases thermal shock on the airfoil. Given the design of high-pressure compressor vanes and blades, the flaking of protective layers affects engines' long-term condition.

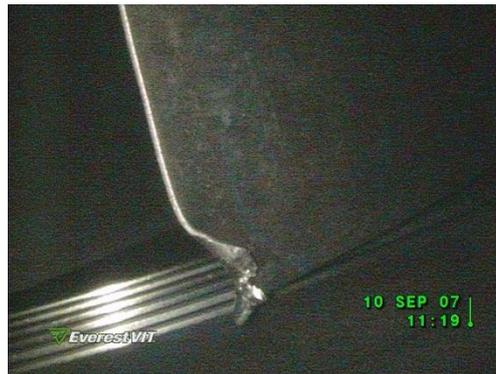
Fig. 9. High-pressure compressor with a leading edge tear

A *tear* occurs when forces act on a part in perpendicular dimension. Contrary to a crack or nick, a tear is not enclosed in one plane and observed when material is pulled apart. Most often, it is caused by the impact of a significant, tough and sharp foreign object.
